Executive Summary  
of  
Sidewalk Buffer Trees  
Survey & Assessment  
Central Coast Maintenance Association  
Nipomo, California

*Prepared by:*  
Sam Oakley  
ISA Board Certified Master Arborist # WE-9474B  
ASCA Registered Consulting Arborist #556  
The Oakley Group LLC  
PO Box 2412  
Pismo Beach, CA 93448

June 2, 2026

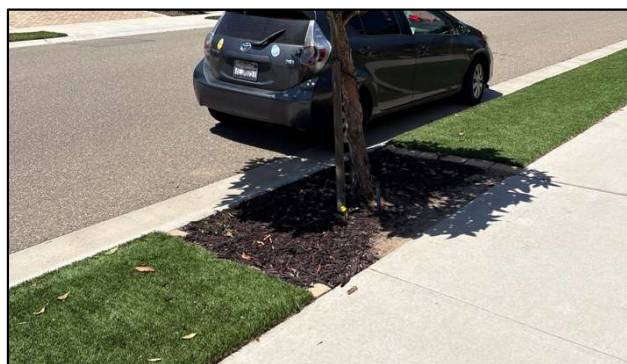
Current wells are frequently undersized relative to tree size, leading to competition with turf irrigation, compaction, and limited nutrient uptake. Expanding all wells to dripline coverage with 4-inches of organic mulch is a foundational recommendation that will dramatically improve tree vigor across the entire inventory.

*Figure 3: the ideal SB1 expanded growing space in with mulch. This tree (Tree 4840) has the only growing space that maximizes*

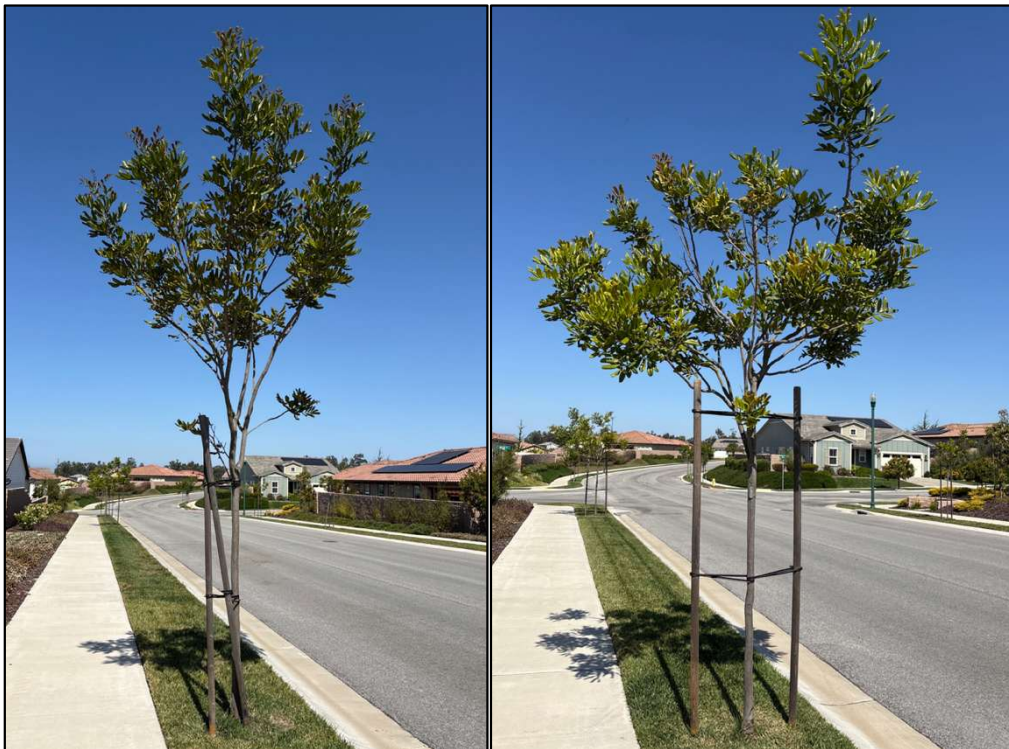
| | Description | Count | Percentage | Primary Context / Species Notes |
|---|---|---|---|---|
| 5 | Staked Improperly or Damaged (Reset/Reposition) | 62 | 4.6% | Stakes are present but incorrect, loose, too tight, or damaged; requires resetting or repositioning to prevent girdling. Mostly not established. |

*Figure 4: (left image) improperly staked tree that needs to be correctly staked until establishment (Code 5); (right image) properly staked tree (Code 4). Tree stakes can be removed on this tree when the trunk is equal to or greater than the stake diameter.*

All future plantings must follow Code 4 (Figure 4) standards at installation and be scheduled for removal under Code 6 at the appropriate time.

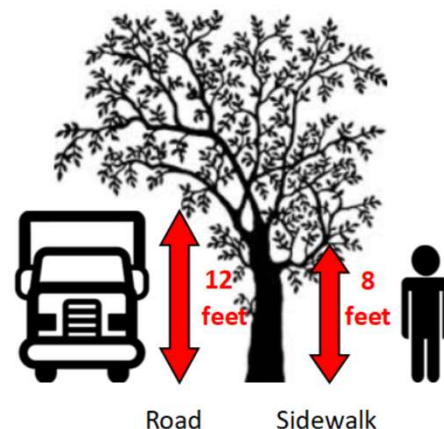
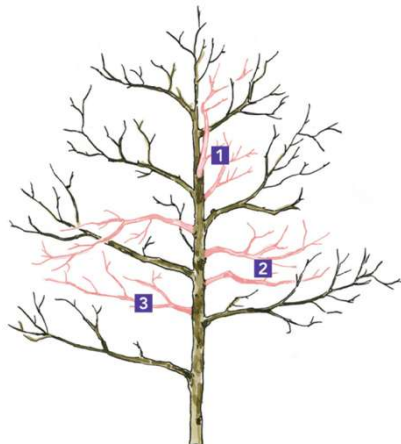
Figure 5: a tree with competing leaders (1) and crossing branches (2 & 3) becomes unstable as it grows. Removing competing leaders promotes apical dominance while improving structure. Structural pruning promotes healthy long-term growth.

- Structural pruning for young and newly planted trees to develop strong architecture (Figure 5).
- Clearance pruning for vehicles (inset; minimum 10-14 feet where possible).
- Clearance pruning for pedestrians (inset; 8 feet where possible).
- Sign clearance (2–3 feet around all regulatory and community signs). Sightlines dependent on speed of the roadway.
- Light clearance (pruning around the zone of influence for streetlights and security fixtures).
- Crown cleaning and thinning to reduce wind resistance and improve light/air penetration.
- Restoration pruning for previously topped trees, with a strict prohibition on future topping.

A three-year pruning cycle is recommended for established trees and unestablished trees.
