Executive Summary  
of  
Sidewalk Buffer Trees  
Survey & Assessment  
Central Coast Maintenance Association  
Nipomo, California

*Prepared by:*  
Sam Oakley  
ISA Board Certified Master Arborist # WE-9474B  
ASCA Registered Consulting Arborist #556  
The Oakley Group LLC  
PO Box 2412  
Pismo Beach, CA 93448

June 2, 2026

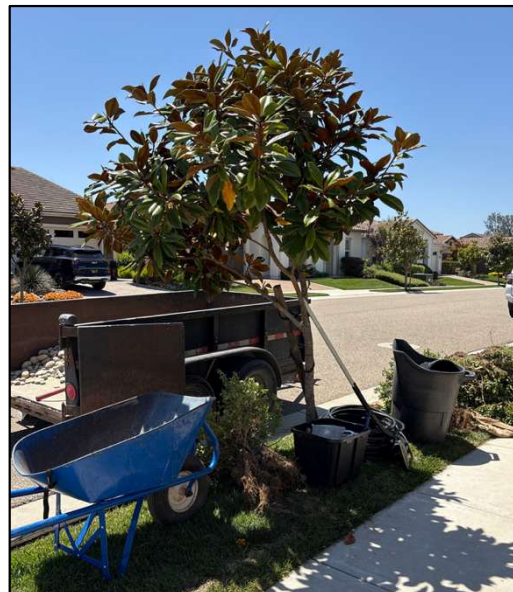
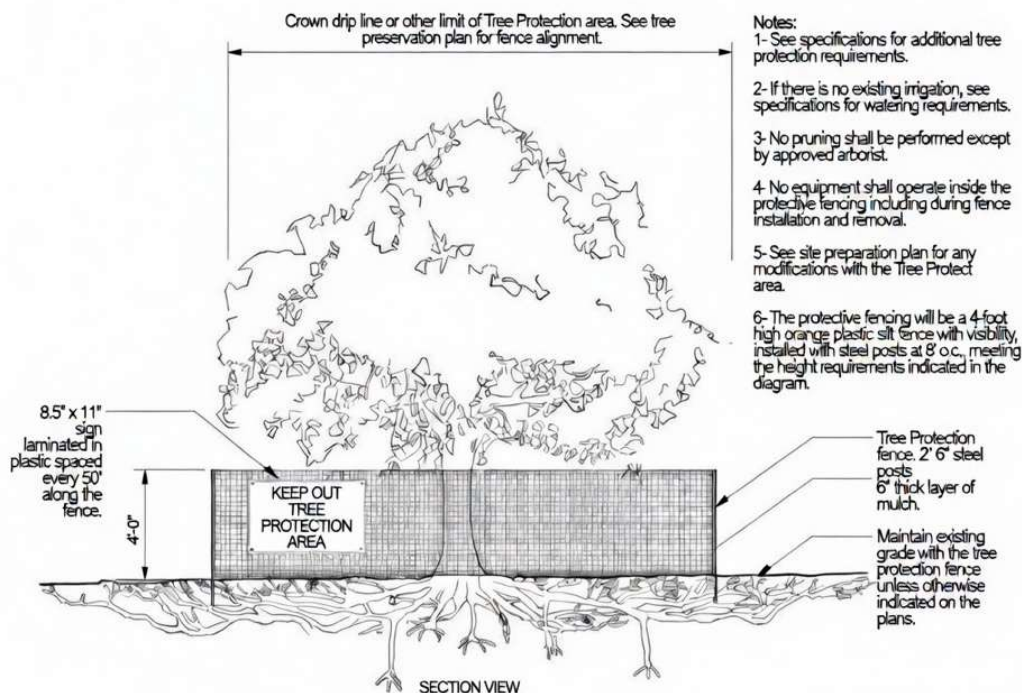
Figure 6: tree protection detail showing the Tree Protection. Tree Protection Zone is to be installed prior to any construction activity to ensure their proper function of protecting the protected oaks. The inset photo on Page 26 shows Tree 437; this scenario damages the tree. A protective fence could prohibit the construction equipment and materials from being staged in this tree's dripline/critical root zone.

Critical root zones (extending to the dripline) must be protected with fencing (Figure 6).

Equipment storage, grading, and material stockpiling within the root zone are prohibited.

Hand excavation is required for any necessary root work.
